Appendix B AIL Route Survey Report

**Nisthill Wind Farm**

Abnormal Indivisible Load Route Survey

August 2022 106319

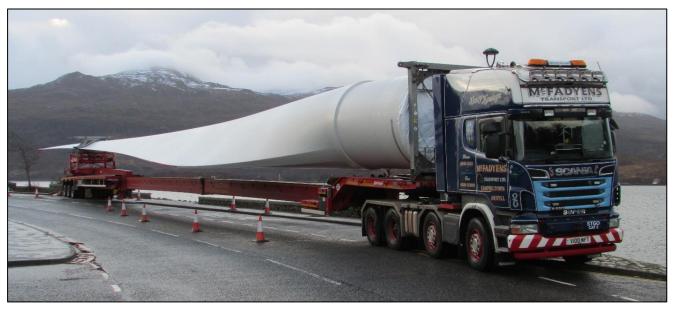
#### Figure 2-2: Superwing Carrier Trailer

To provide a robust assessment scenario based upon the known issues along the access route, it has been assumed that all blades would be carried on a Superwing Carrier trailer to reduce the need for mitigation in constrained sections of the route.

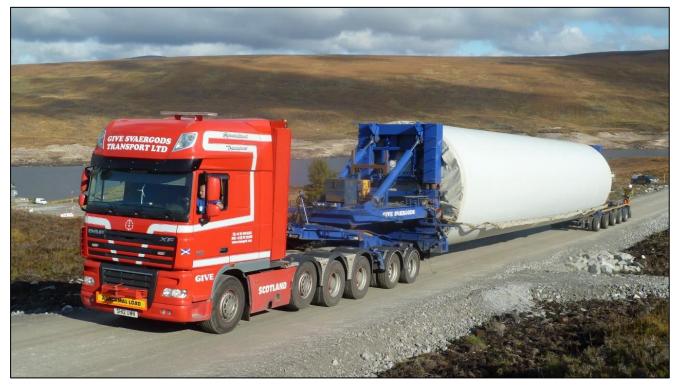
#### Figure 2-3: Tower Trailer

The base and mid towers would be carried on a 4+7 clamp adaptor style trailer. The hub, nacelle housing, and top towers would be carried on a six-axle step frame trailer.

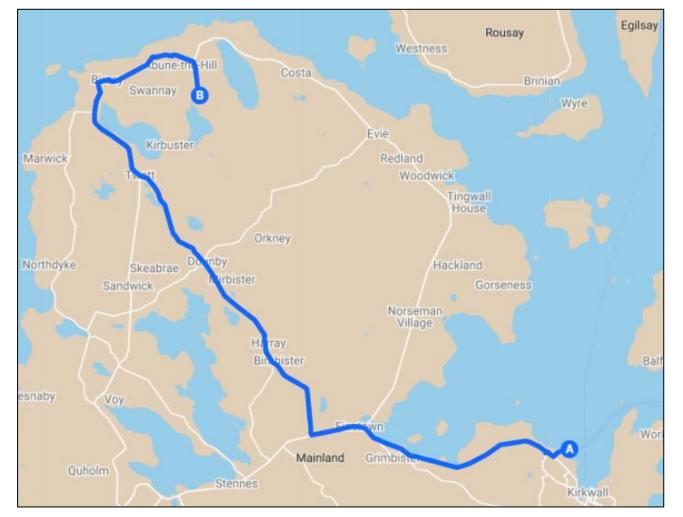
#### Figure 3-1: Proposed Access Route Option 1

- > Loads would exit onto the docks and proceed westbound through the Hatston Industrial Estate;
- Loads would turn right onto Grainshore Road, undertaking a contraflow manoeuvre and proceeding northwest;
- Loads would continue onto the A965 and proceed northwest;
- > Loads would turn right west of Finstown to join the A986 northbound;
- > Loads would continue onto the A967 at Twatt and proceed northbound; and
- > Loads would turn right onto Wattle Road south of Birsay and proceed to the site access.

The proposed access route for Option 1 is illustrated in Figure 3-1.

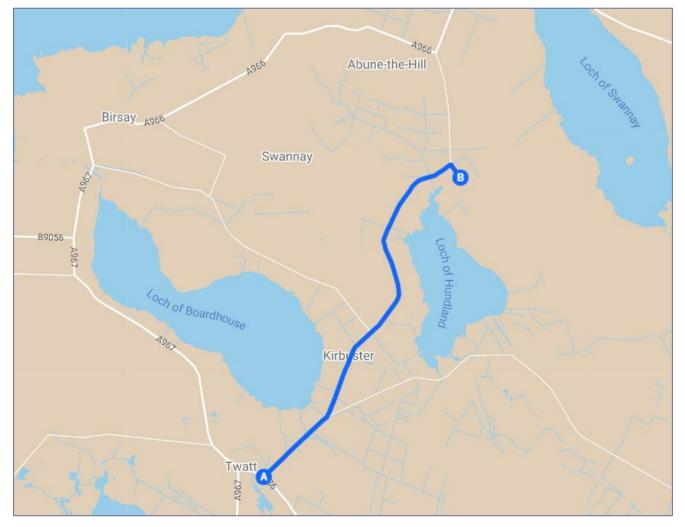
Figure 3-2: Proposed Access Route Option 2

The access route for Option 2 is the same as Option 1, with the exception that loads turn right at Twatt and proceed northeast on Hundland Road, passing Kirbuster. This option avoids the bends on the A967 and A966. The section from Twatt to site is illustrated in Figure 3-2.
