Nisthill Wind Farm  
EIA Report

Figure 3.6

Indicative Tracks

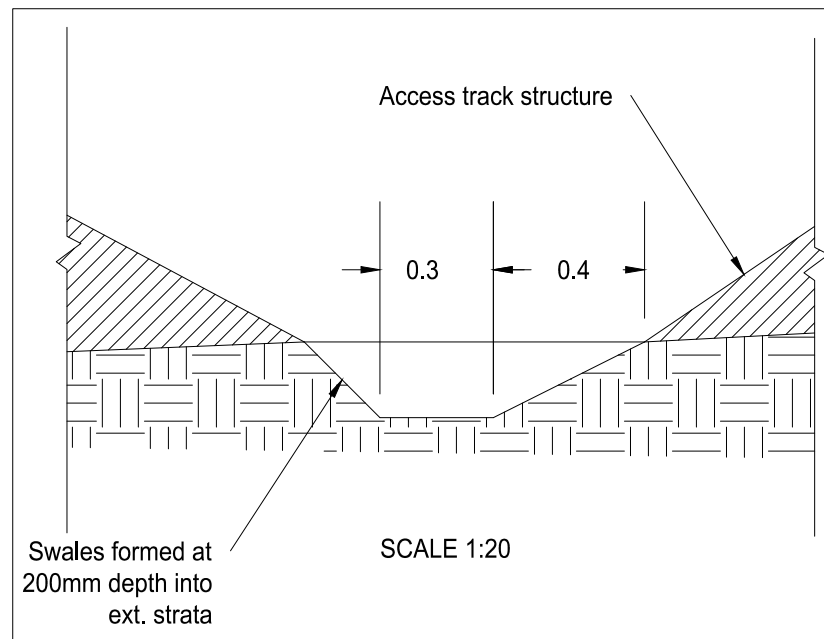
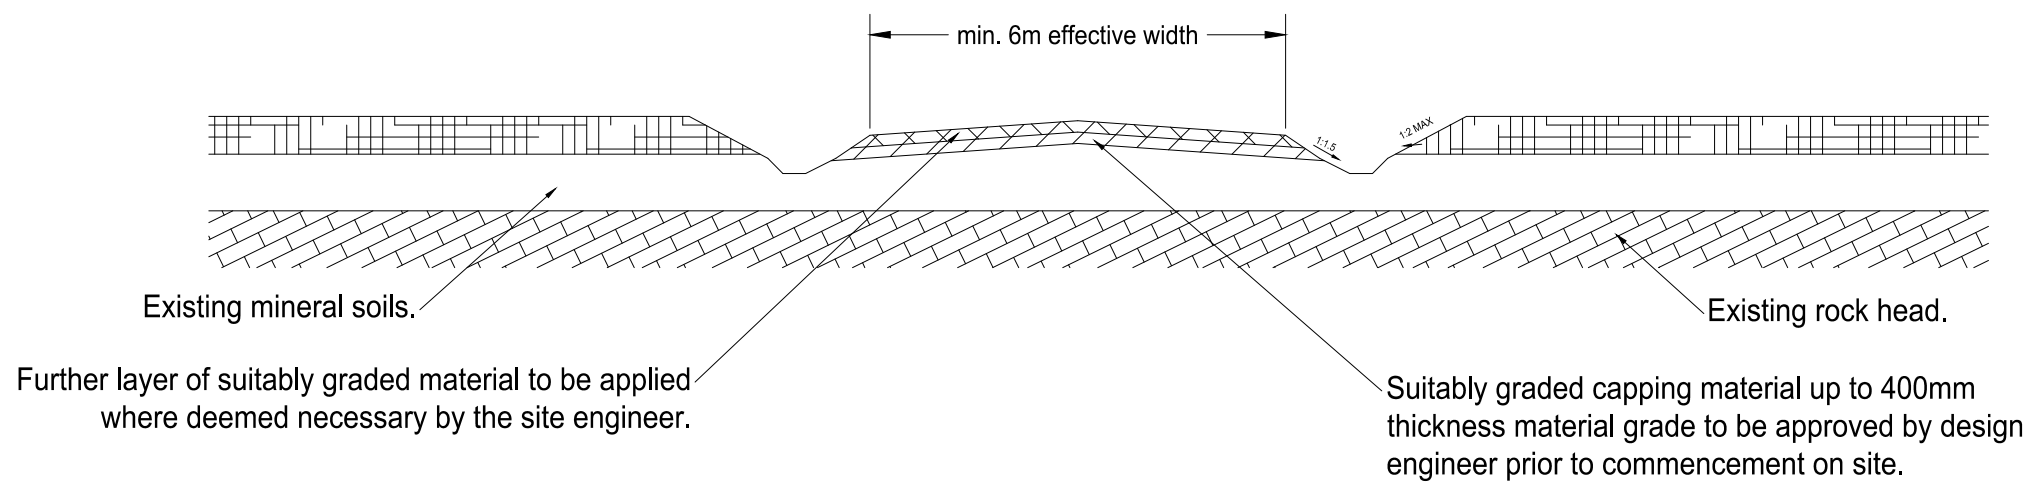
**TYPICAL TRACK FORMATION ON OVERBURDEN SOIL**  
SCALE 1:100
